# Arboricultural Report

BS5837:2012 Trees in Relation to Design, Demolition  
and Construction - Recommendations

**Client:** Gas Networks Ireland

**Project:** Gas to BnM Edenderry

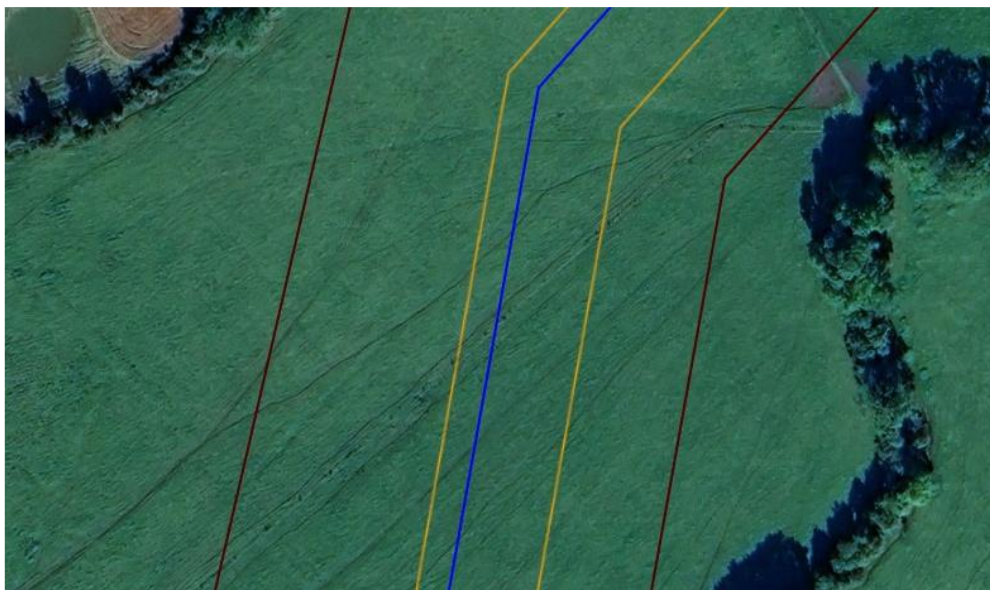
**Figure 2:** Example of proposed pipeline route detail.

4.2 The proposed development consists of the construction of an underground gas transmission pipeline, approximately 23.65 km in length, linking the existing Dublin to Galway high-pressure gas pipeline to the Bord na Móna Edenderry Power Station. An example of the pipeline route is shown in blue below, the working width in orange, and the survey corridor in red (fig. 2).

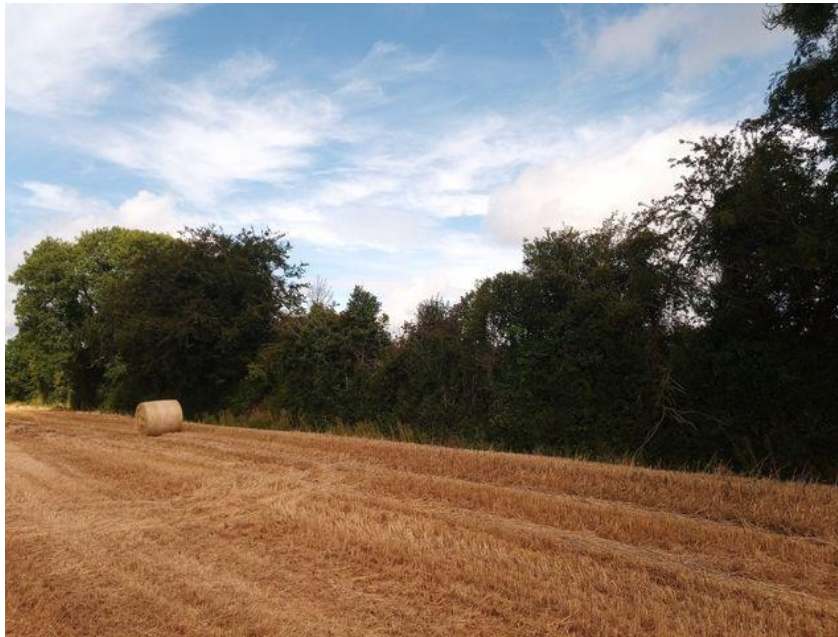
**Figure 3:** H002 Mixed species early mature hedgerow.

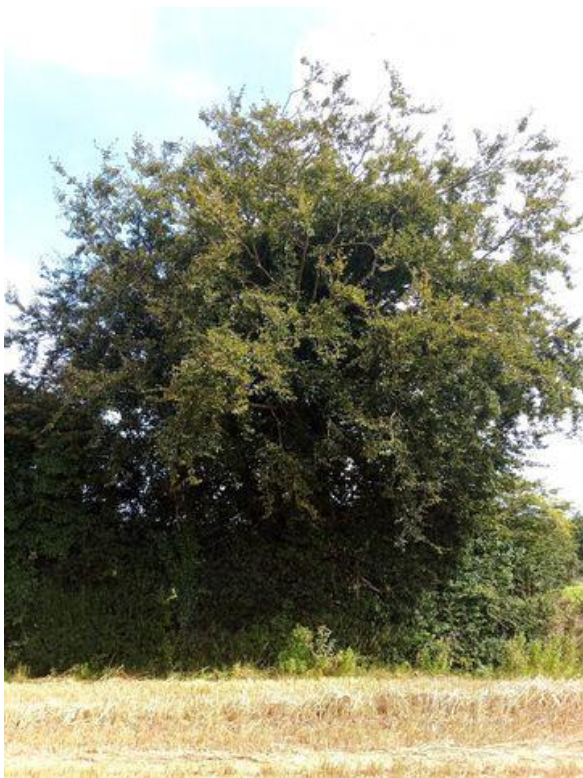
**4.3** The development route begins in an agricultural field to the north of the R161 before continuing southwest through fields and hedgerows until it crosses the R161. Many of the hedgerows are unmanaged and sprawling, mostly comprised of hawthorn and blackthorn (H002: fig. 3) with the occasional holly, and an overstory of mature beech (T1738: fig.4) and ash (T1752: fig.5).

**Figure 4:** T1738 Early mature beech.

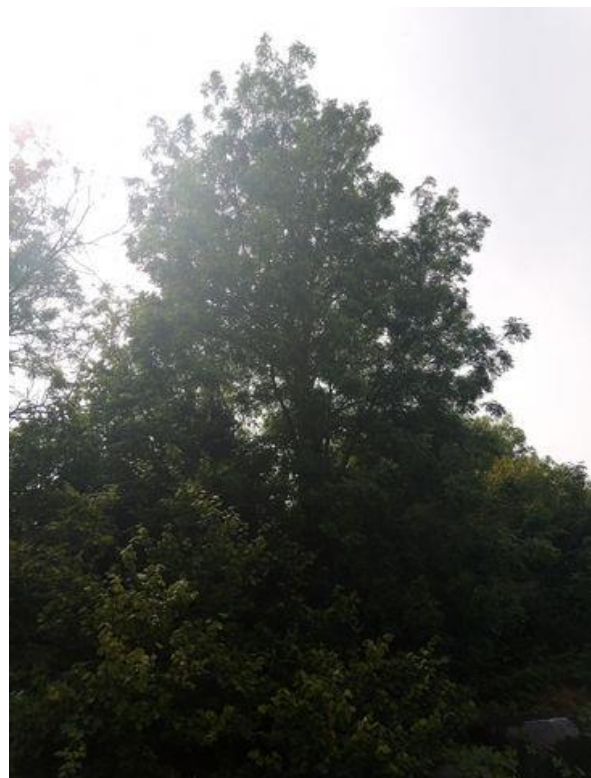
**Figure 5:** T1752 Early mature ash.

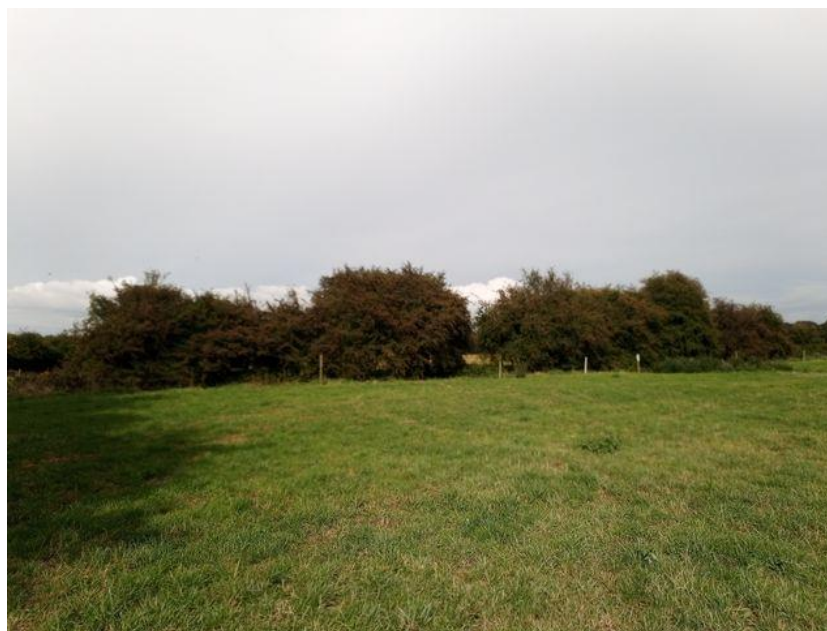
**4.4** The proposed pipeline route continues southward, crossing the Kilwarden River and the R148 before it meets the M4 motorway, routing beneath it. The hedgerows vary in character, some managed on a regular basis, others more open and sprawling (H018: fig. 6). Many of the hedgerow trees are of a great age, and display veteran characteristics, such as the pair of lapsed pollard beech (G010: fig 7).

**Figure 6:** H018 Open and sprawling hedgerow.

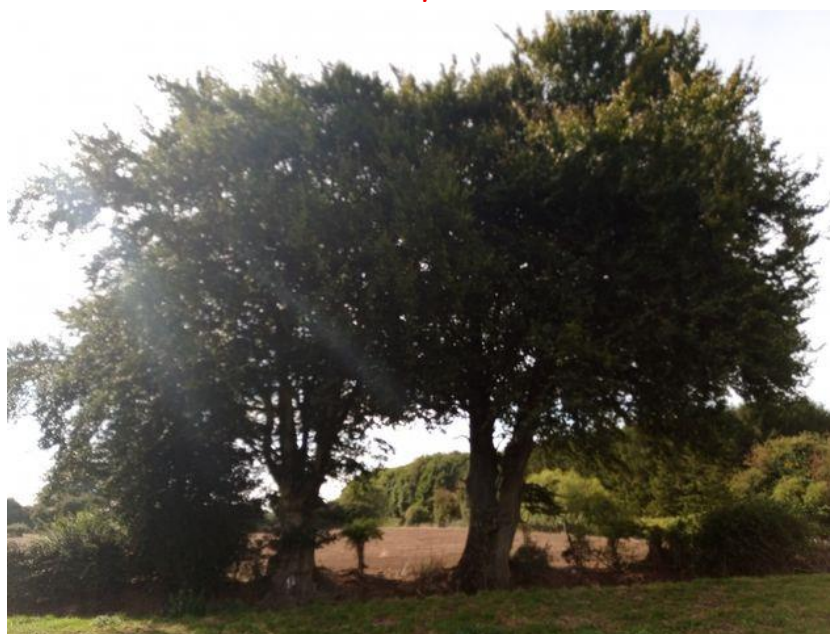
**Figure 7:** G010 Veteran lapsed pollard beech.

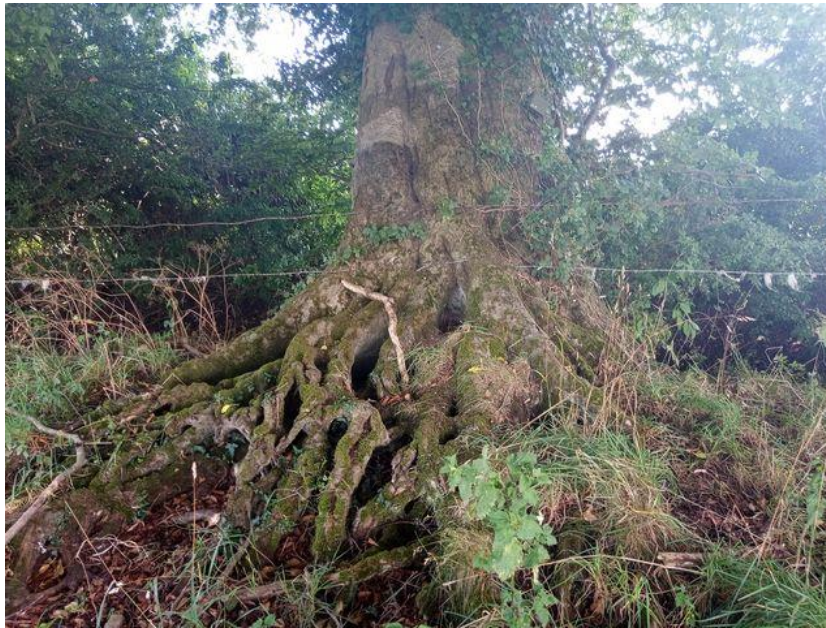
**4.5** The proposed pipeline continues southward, through fields and hedgerows, crossing the L4181 and a minor road at Park, before crossing the R401. Impressive mature treelines are within this section, and the proposed pipeline route skirts the RPAs of some enormous veteran trees, including (T1809: fig. 8). The hedgerows continue to vary in character, including those managed on a regular basis (H041: fig. 9).

**Figure 8:** T1809 Veteran beech.

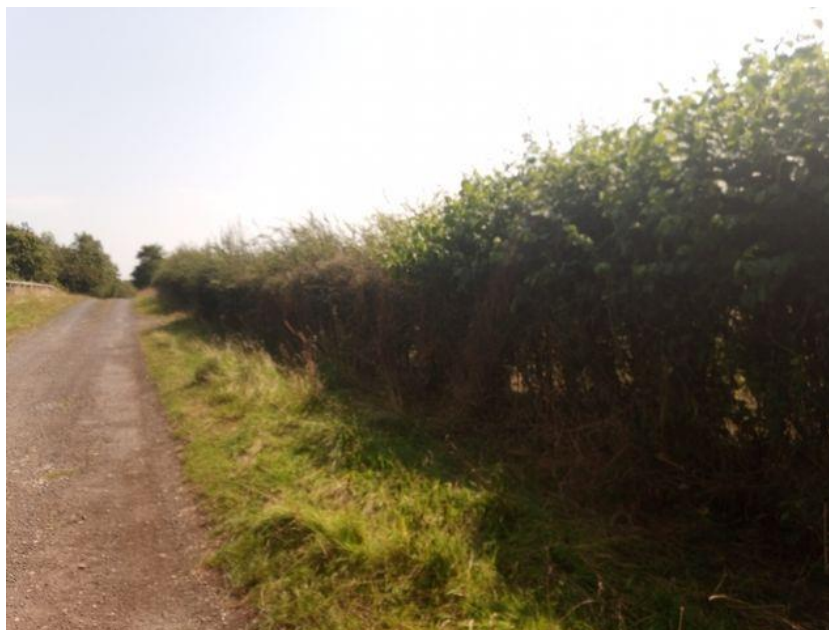
**Figure 9:** H041 Managed hawthorn hedgerow.

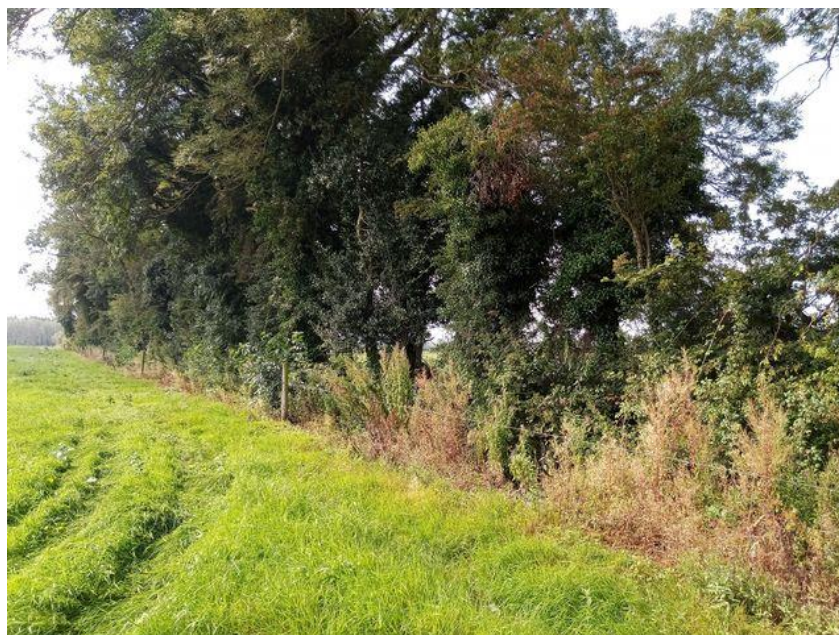
**4.6** Continuing southward, the proposed pipeline crosses the L4091 at Ballynakill before reaching the Yellow River, close to its confluence with the River Boyne. Mature treelines (G054: fig. 10) rising above unmanaged hedgerows are typical of this section (H075: fig. 11).

**Figure 11:** H075 Unmanaged mixed species hedgerow.

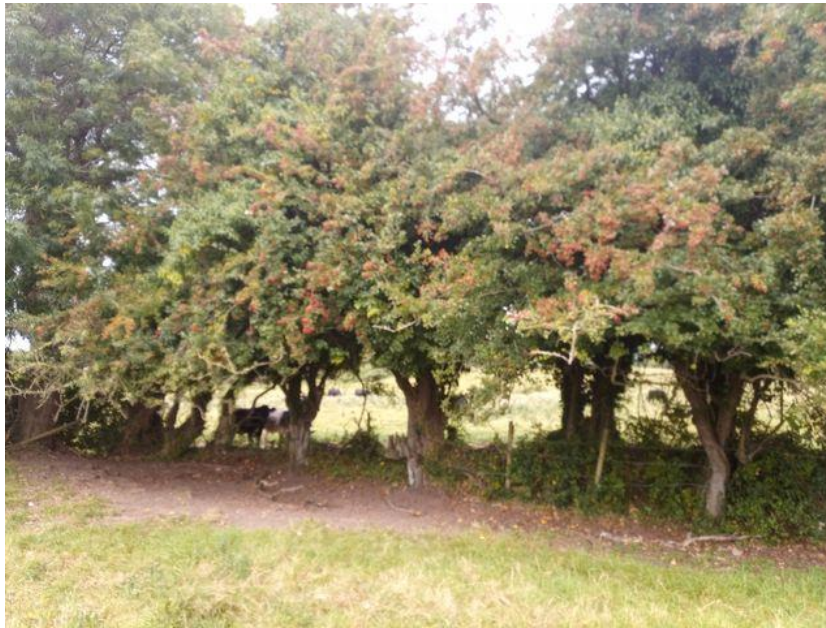
**4.7** The proposed route traverses agricultural fields and hedgerows before veering in a south westerly direction, crossing the L1004 and a minor road at Roosk before continuing southward, crossing the R441 and the L5007 at Monasteroris. Many of the hedgerows are lapsed (H095: fig. 12) or unmanaged and sprawling, and there are veteran ash (T1939: fig.13) and oak (T1940: fig. 14) dotted along the route.

**Figure 12:** H095 Lapsed hawthorn hedgerow.

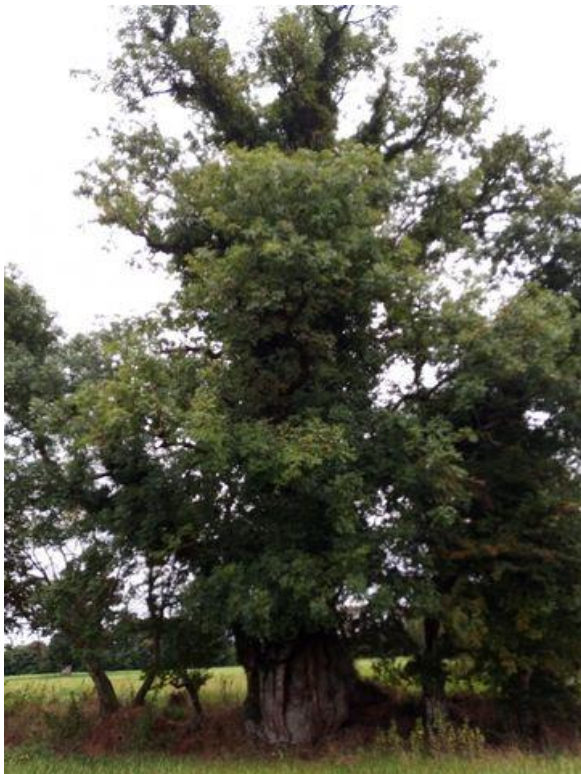
**Figure 13:** T1939 Veteran ash.

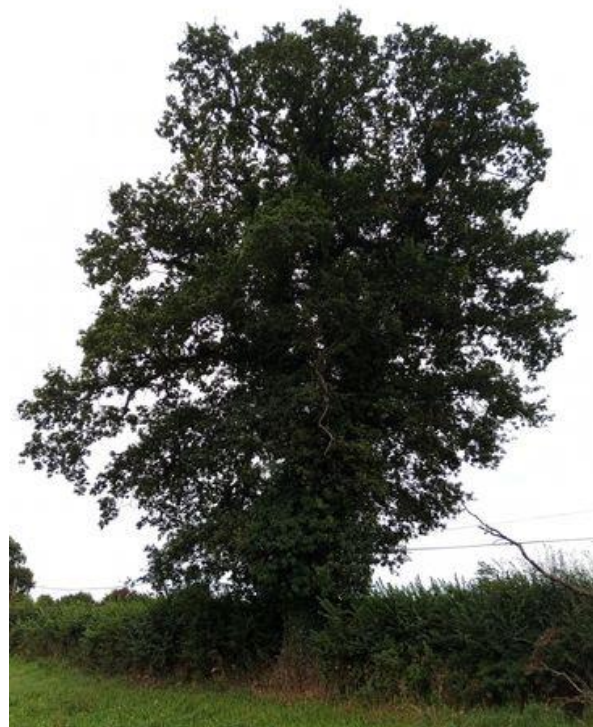
**Figure 14:** T1940 Veteran pedunculate oak.

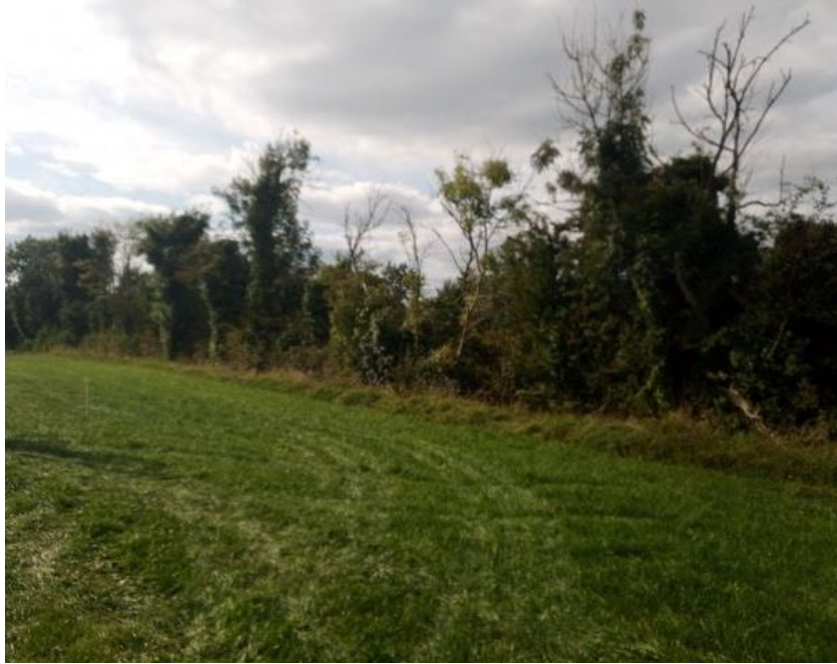
**4.8** The proposed pipeline is routed beneath the Grand Canal to the west of Rathmore Bridge, before crossing the R402 and the L5003. The hedgerows in this section vary in character, some sprawling and unmanaged, with dead and dying ash trees within (H137: fig. 15), some regularly trimmed (H144: fig.16).

**Figure 15:** *H137 Unmanaged boundary hedgerow.*

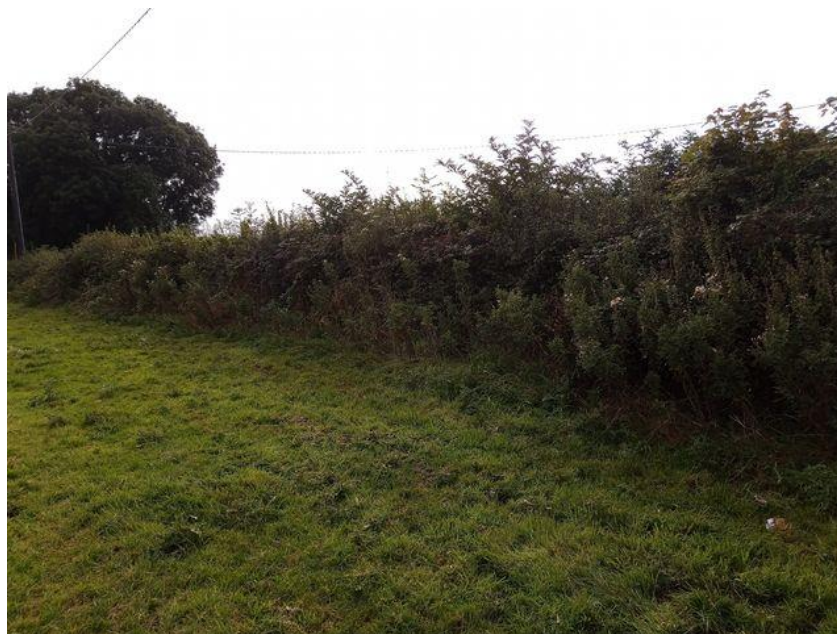
**Figure 16:** *H144 managed boundary hedgerow.*

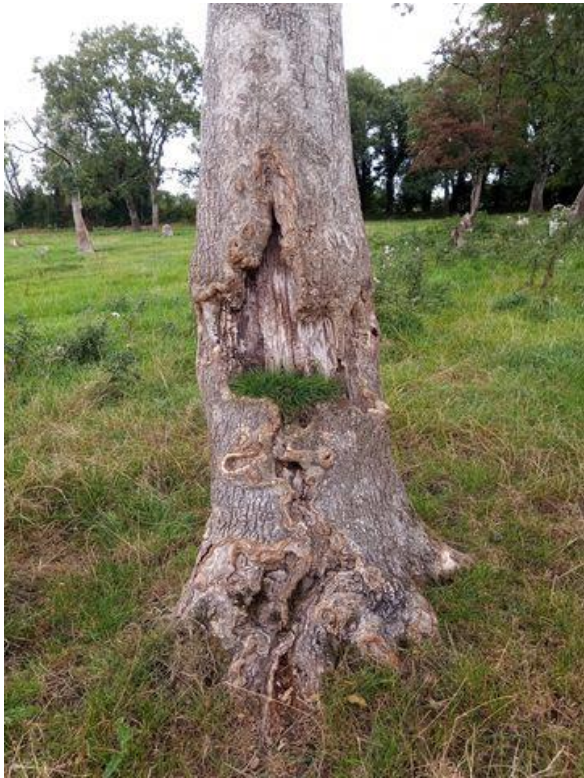
**4.9** At this point, the proposed pipeline route veers southwestward, crossing fields and hedgerows, before reaching the R401 and the Edenderry Power Station. The proposed pipeline route is through a stand of veteran ash (T2000 & T2005: figs. 17 & 18) many with cavities, deadwood, and fungi present. The hedgerows in this section are typical of many along the route (H157: fig 19).

**Figure 17:** T2000 Veteran ash with cavities.

**6.10** Many of the trees throughout the route possess veteran features, either due to great age, to historic damage, or to both. Veteran features include cavities, deadwood, and the presence of wood decay fungi. The retention of veteran trees in the landscape is important due to their rich biodiversity and the habitats they provide for numerous species of plants, fungi, invertebrates, bats, small mammals, and birds. Veteran trees also provide significant ecosystem services, including carbon storage, soil enrichment, and landscape connectivity.

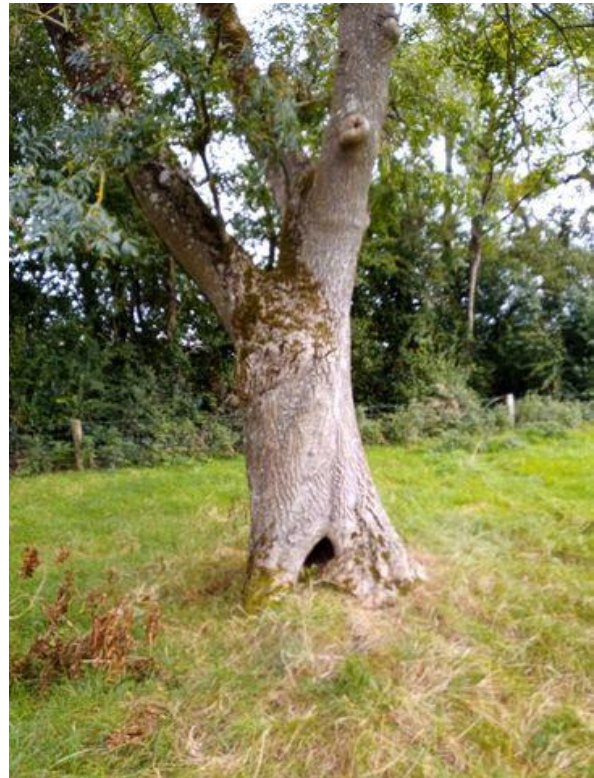
**Figure 18:** T2005 Ash with cavity feature.

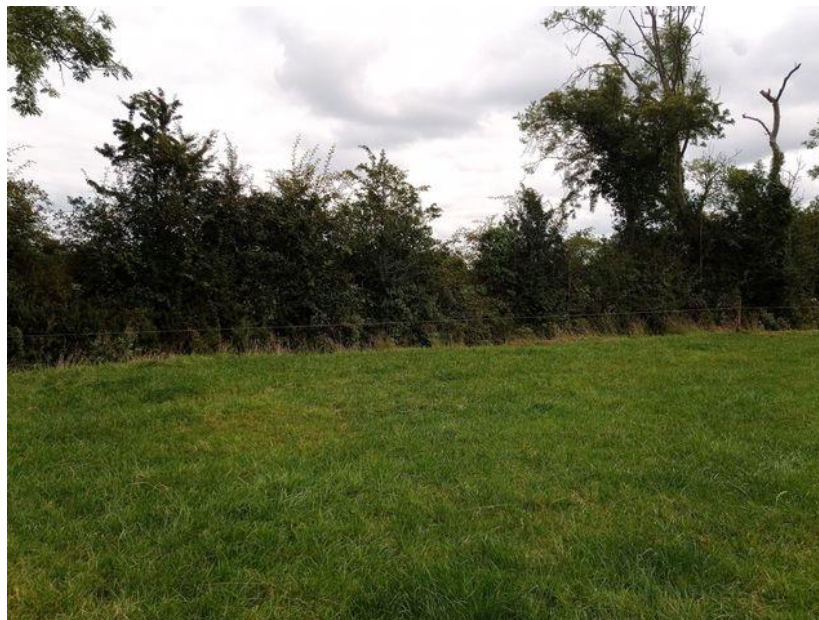
**Figure 19:** H157 Lapsed hedgerow with dead ash stems.

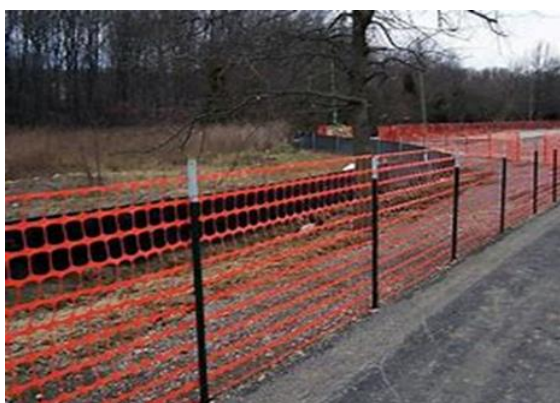
**Figure 2:** Euromesh.

On completion of any tree works, protective fencing (fig. 1) must be erected at the edge of the RPA, at each phase of works, in accordance with BS5837:2012. Trees remote from construction works may be protected using a lower specification fencing such as Euromesh (fig. 2), or no fencing at all if deemed appropriate by the project arboriculturist. Fencing is intended as a precaution to prevent accidental damage to the rooting area of retained trees. The positioning of any fencing at the edge of the RPA is shown in the TPP as an orange line.

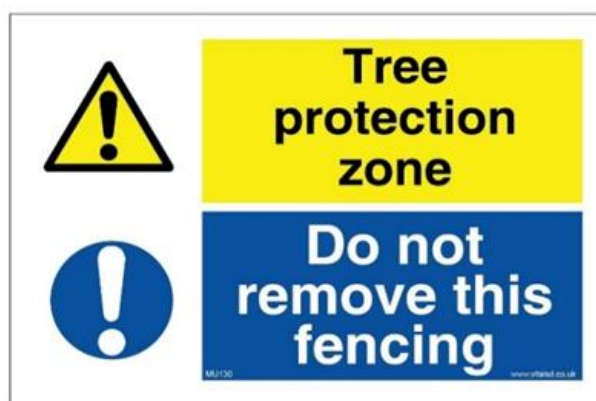
**Figure 3:** Signage to be affixed to barrier.

- Erection of protective fencing must be completed before any materials or construction machinery are brought onto site and before any construction works commence.
- Signage (fig. 3) indicating 'tree protection area, no construction access' or similar must be affixed to the protective fencing.
- Fencing is not to be removed or repositioned without the approval of the project arboriculturist
